# Lead risk and remediation strategies in public areas of Broken Hill, NSW

**FINAL REPORT**

**Prepared for the New South Wales Environment Protection  
Authority Broken Hill Environmental Lead Program by**

Department of Environmental Sciences, Macquarie University

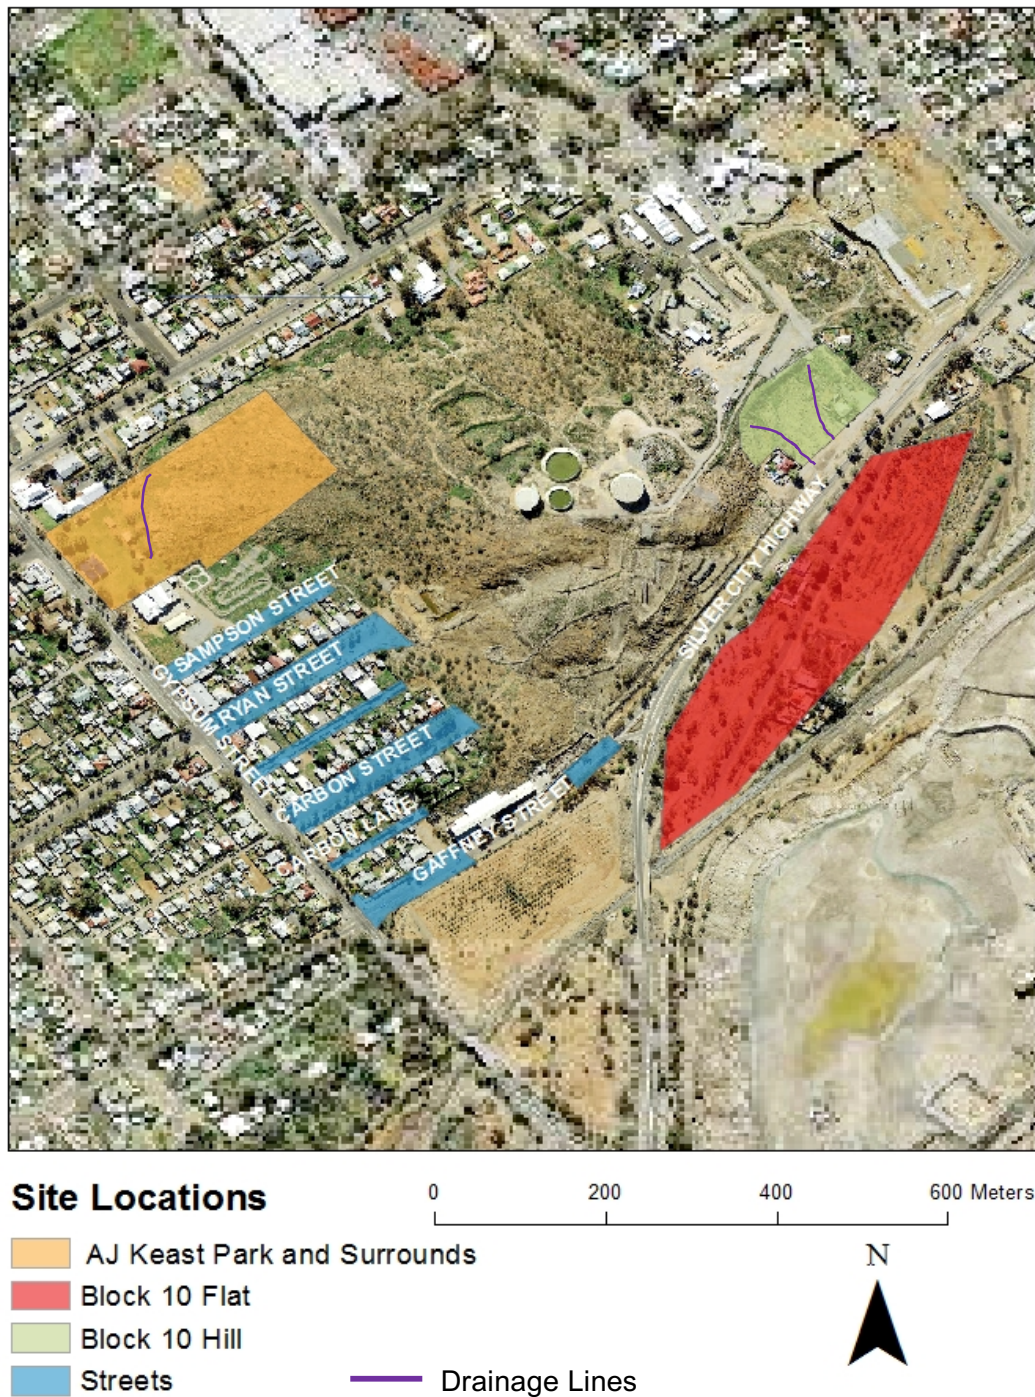
Figure 1. Locations of sample sites in the Block 10 Area

Contamination on Block 10 Hill appears to be mostly entering the site through the two drainage lines running from either side of the hill, towards the centre (Figure 1.). It would appear that previous remediation to stabilise the drainage lines has not been successful in removing the contaminant from the site. This could be due to the contaminant being based off site, and transported onto the site via the drainage lines during periods of heavy rainfall. As there are three houses in the immediate area of the site, as well as evidence of human activity (rubbish and dumped asbestos sheeting) on the site itself, these high concentrations are particularly concerning.

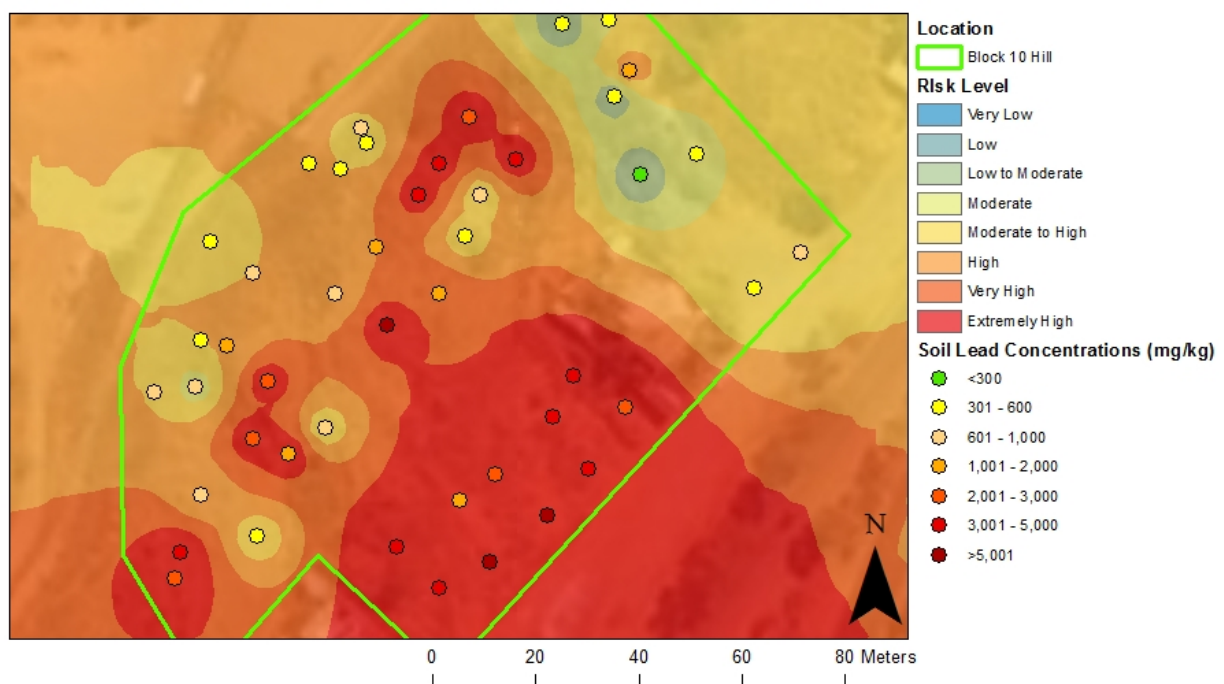
Figure 10. Soil lead concentrations and overall risk at Block 10 Hill

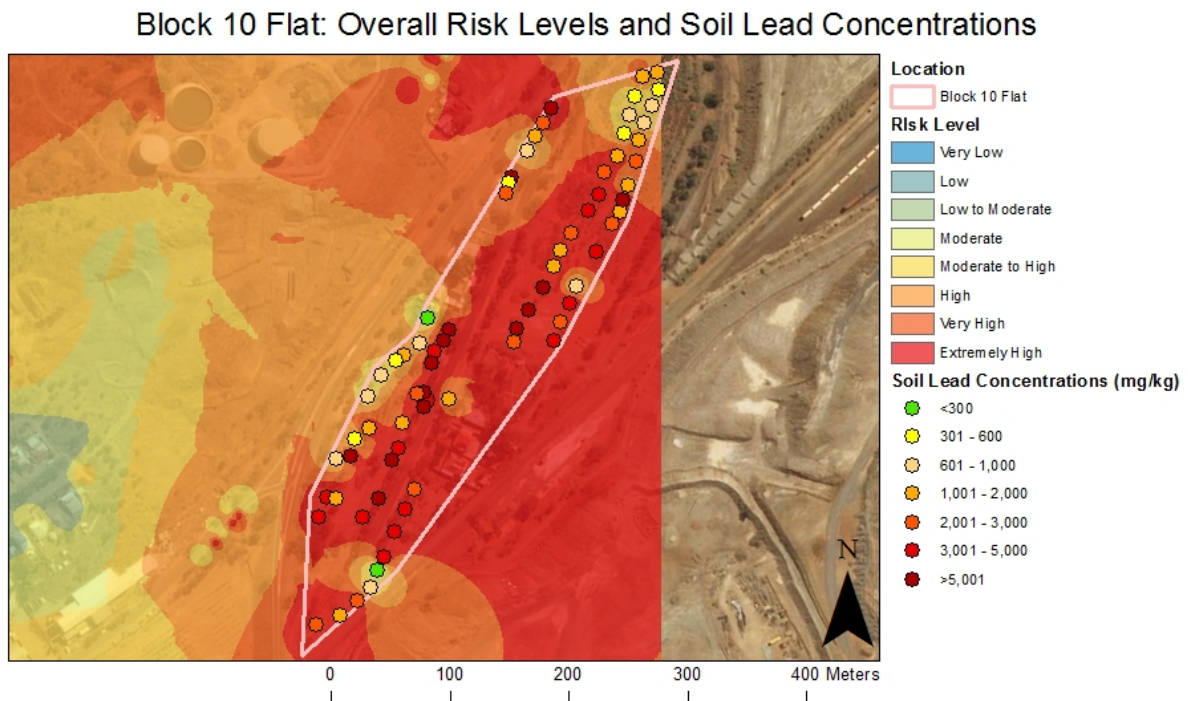
Out of the 72 measurements, two had lead concentrations <300 mg/kg, six were within a range of 301-600 mg/kg and fourteen were >5,001 mg/kg (Figure 14.). A greater amount of >5,001 mg/kg concentrations were detected along the access road where vegetation was minimal, whereas scattered distributions of 1,001-5,000 mg/kg concentrations were present throughout the north-west section of land on the Block 10 Flat (Figure 14.). To the north-east, where risk levels were determined to be predominantly moderate, lead concentrations were found to be 301-2,000 mg/kg. To the north-west, lead concentrations were mostly >301 mg/kg. As noted in Table 5., the lead concentrations were the highest – 20,199 mg/kg, the lowest – 124 mg/kg, the median – 2,334 mg/kg, and the mean – 3,417 mg/kg.

Road and the access road, demonstrated varying levels of risk from moderate to extremely high (Figure 14.).

Figure 14. Soil lead concentrations and overall risk at Block 10 Flat.

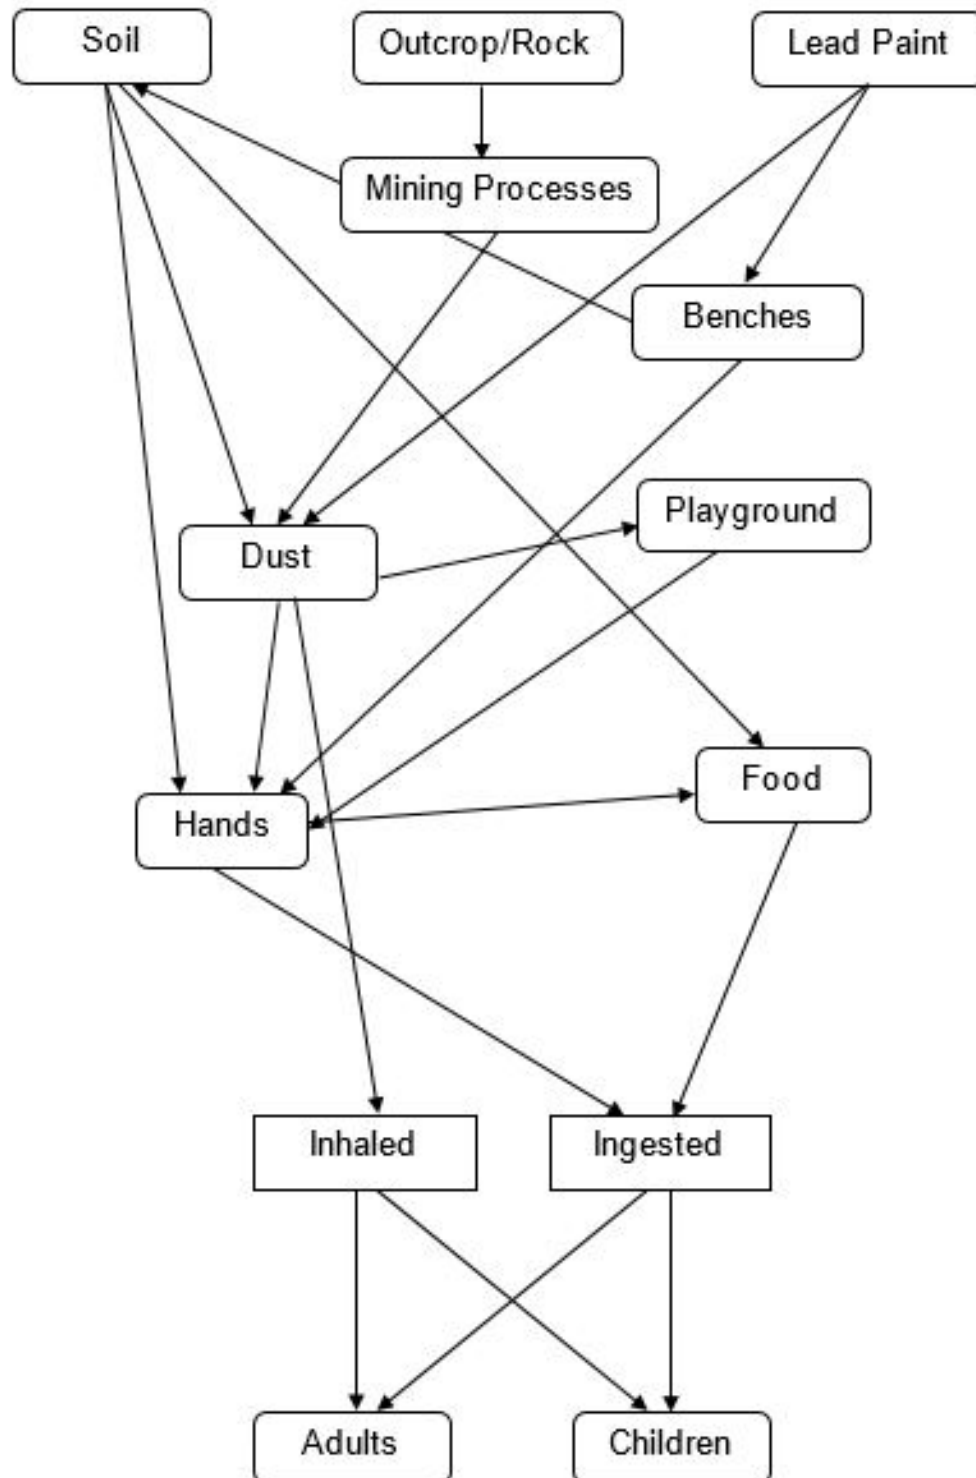
This flow chart describes the pathways of lead exposure in the Broken Hill community.
