An audit of previously remediated sites in Broken Hill

Prepared for Broken Hill Environmental Lead Program by:

Faculty of Agriculture and Environment

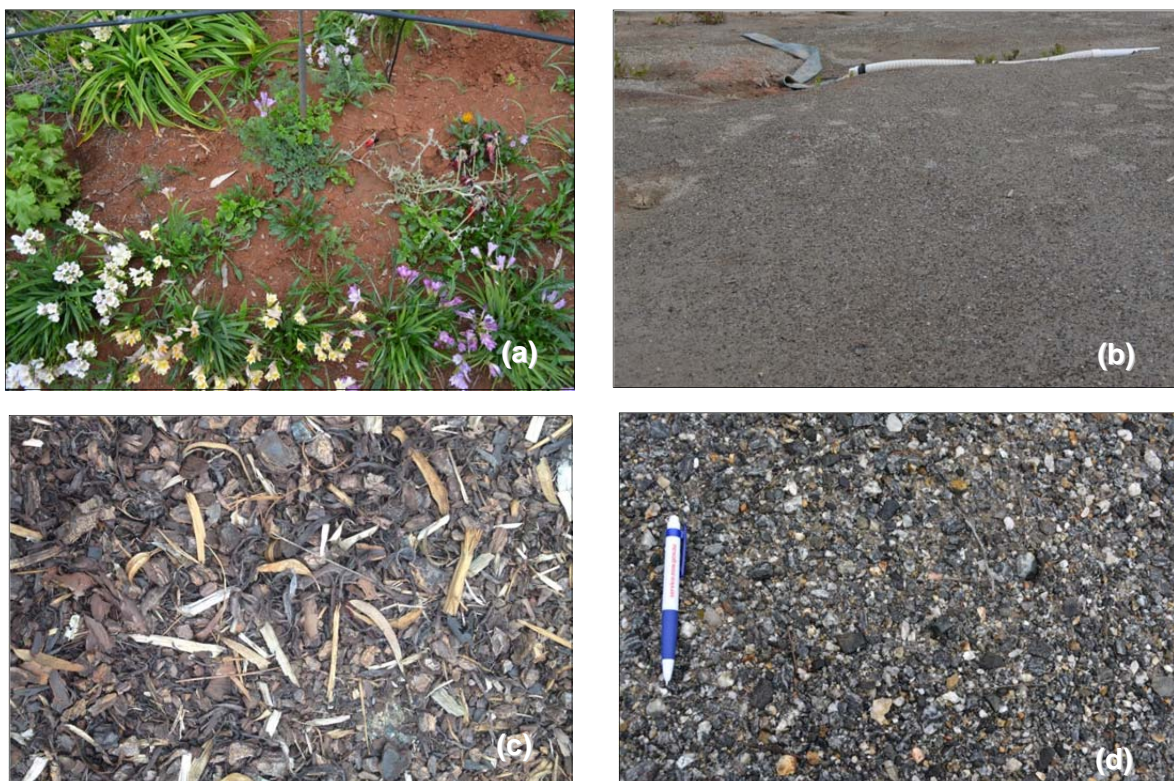
Figure 2. Examples of the main abatement materials used in Broken Hill; (a) garden loam, (b) cracker dust, (c) wood chips and (d) blue metal/road base.

The clean materials used were predominantly wood chips, garden loam and cracker dust, although on some properties blue metal (road base), gravel/pebbles and coarse sand was used. There appears to be only a weak correlation between the antecedent topsoil Pb concentration and the abatement strategy used, although garden loam was the most commonly used clean material (46% of occurrences), 100 mm was the most common excavation depth and 50 mm was the most common top-dressing depth. Generally, lawn areas were treated with garden loam or cracker dust, garden beds were finished in wood chips, bare areas and driveways were finished in cracker dust or blue metal, and other areas (e.g. BBQ areas, sand pits) were finished with new materials to match the existing ones. In some cases, existing lawns were only top-dressed to 50 mm depth (irrespective of topsoil Pb concentration) to ensure grass survival.

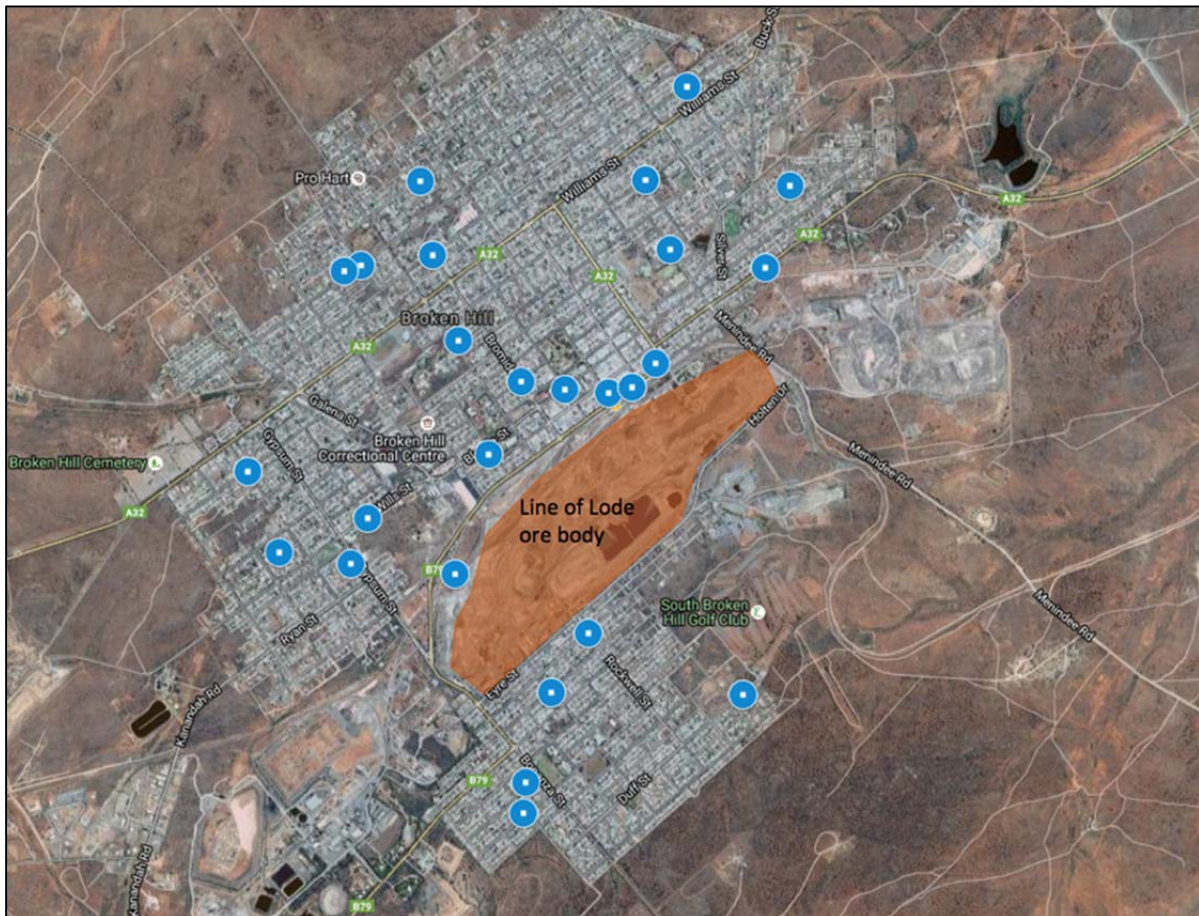
Figure 3. The distribution of previously-abated residences and public access areas re-assessed for topsoil Pb concentrations in 2016.

A total of 39 previously-abated residential and public access locations were assessed for current condition and topsoil Pb concentrations, and these were widely spread across both the northern and southern urban areas of Broken Hill (Figure 3). Across these 39 locations, a total of 153 measurements of current topsoil Pb concentrations were obtained, of which 115 could be directly compared to topsoil Pb concentrations measured at the same spot prior to abatement (Appendix 3). For many of the residential yards visited, one or more previously Pb-assessed and/or abated spots were not accessible for follow-up measurements due to paving, concreting or new buildings/infrastructure. For the 10 public access locations assessed, none of the antecedent topsoil Pb concentrations were available, but it is understood that these measurements were made prior to abatement/remediation.

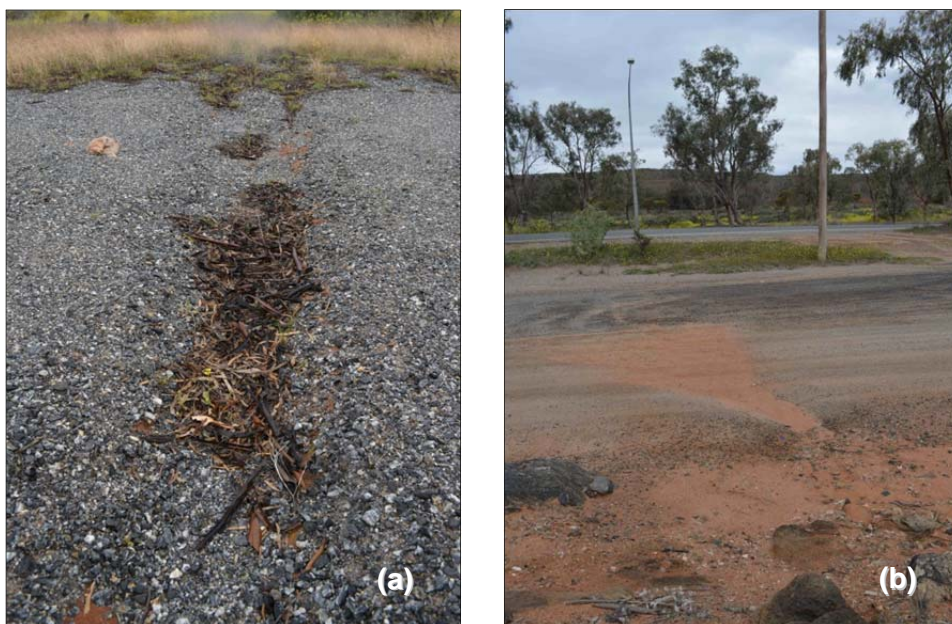
Water and wind erosion are two physical, surficial processes that have clearly had an impact on some previously-abated surfaces in Broken Hill. The householder at [redacted] Wills St reported that the original abatement capping of wood chips had completely washed away during a heavy rain, while at a number of the vacant blocks along Eyre St there was clear evidence of rill erosion breaking up the pre-existing abatement surfaces of road base and cracker dust. In the case of [redacted] Eyre St (Figure 8a), the intact road base had a surface Pb concentration of 185 mg/kg, whereas patches of exposed soil had a Pb concentration of 4183 mg/kg. The vacant block at [redacted] South Rd Lane also shows considerable evidence of water erosion, with plumes of Pb-rich reddish sediment clearly evident across the lane surface (Figure 8b). These plumes of sediment contained more than 3000 mg Pb/kg, whereas the laneway gutter sediment contained only 700 mg Pb/kg.

Figure 8. Examples of eroding surfaces exposing or transporting Pb-rich soil and sediment. (a) is at [redacted] Eyre St, and (b) is at [redacted] South Rd Lane.

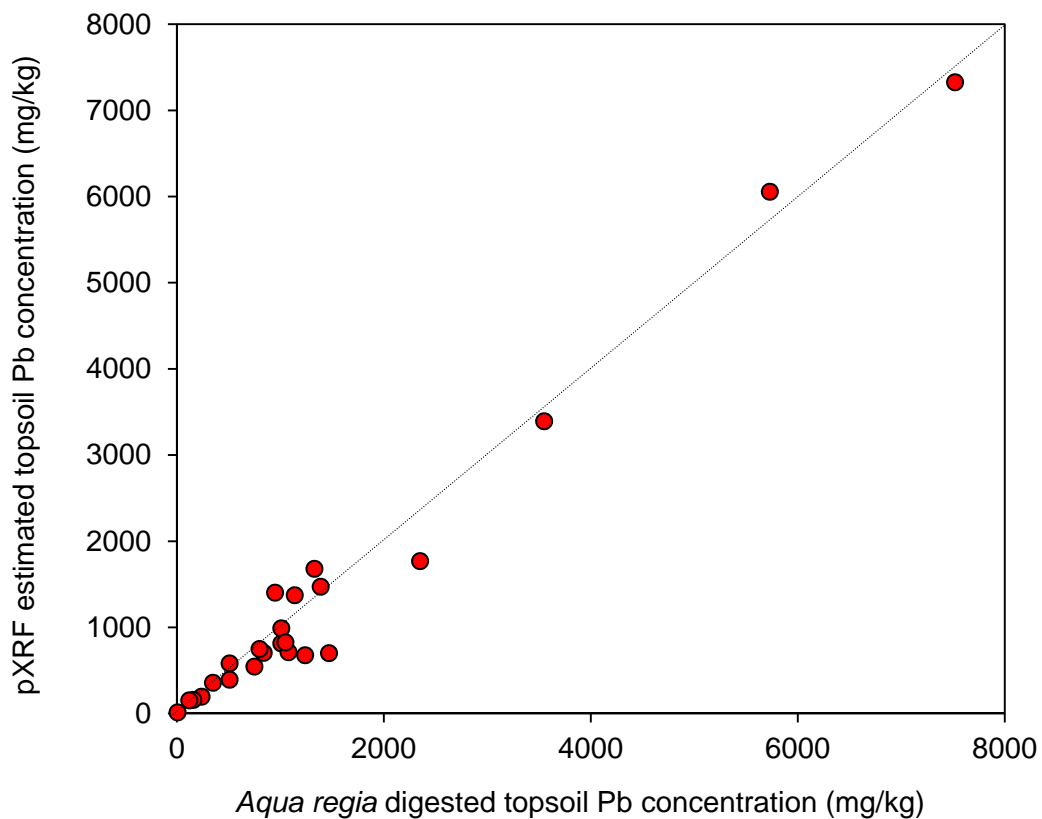
Appendix 4. Comparison data for the pXRF-estimated and *aqua regia*-digested, ICP-MS measured topsoil Pb concentrations. The dashed line is the 1:1 line.

These comparative data show that the pXRF performed very well in the field, predicting Pb concentration values very closely to those estimated by *aqua regia* digestion and ICP-MS analysis in the laboratory. There is some discrepancy in the values for those samples with between 1000 and 2000 mg/kg, but the sample analysed in the laboratory was taken from a larger surface area than the target soil scanned by the pXRF in the field.
